ARMY RESEARCH LABORATORY

Mechanical Tests and Failure Analysis on Selected Components of the Class 60 Armored Vehicle Launched Bridge (AVLB) During the Class 70 Modification Program

ARL-TR-1269

December 1996

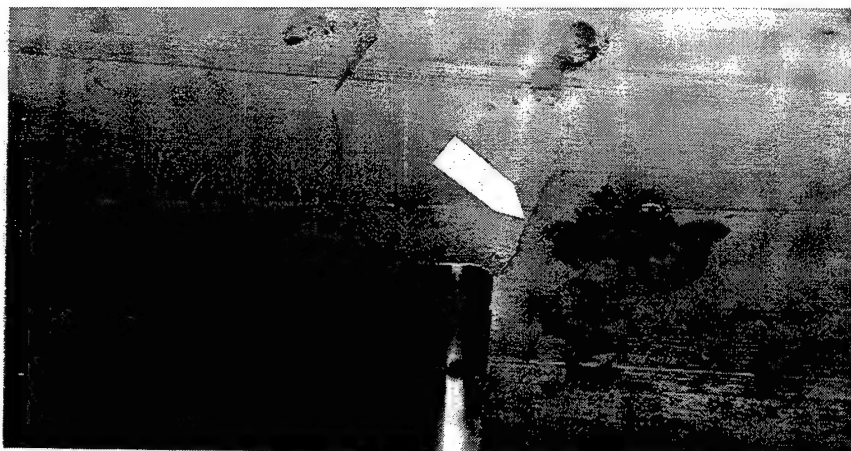
Figure 6. A close-up view of a crack (arrow) at the corner radius of the bottom chord inner aluminum angle where its horizontal leg was cut off to accommodate the thicker bottom flange (dark area in lower left-hand corner of the photograph of the inboard steel beam girder). Magnification: 1.28x.

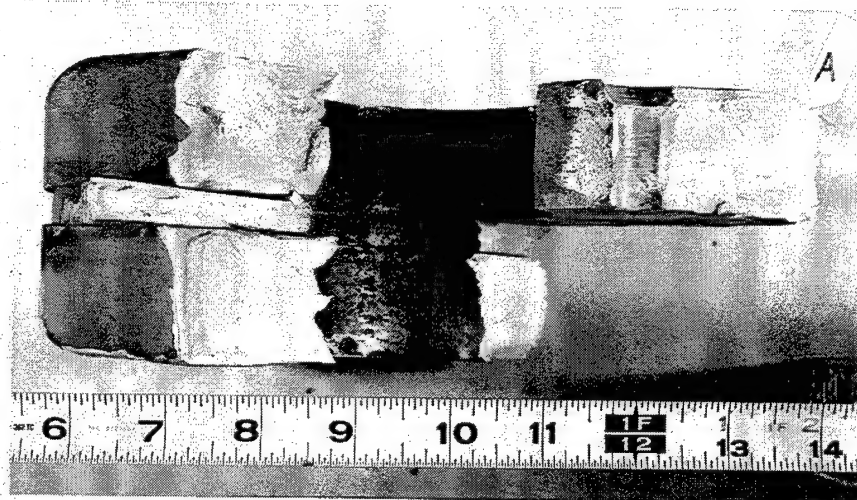
Figure 8. Top view of the broken section in Figure 7, showing the fractured surfaces. Two forged aluminum connector parts were riveted to a 3/8-in-thick inboard girder web aluminum plate (between the forged parts). The top broken piece is a section of the forged inboard connector part, whereas the bottom piece is a section of the outboard connector part. The location at A is the origin of the brittle failure.

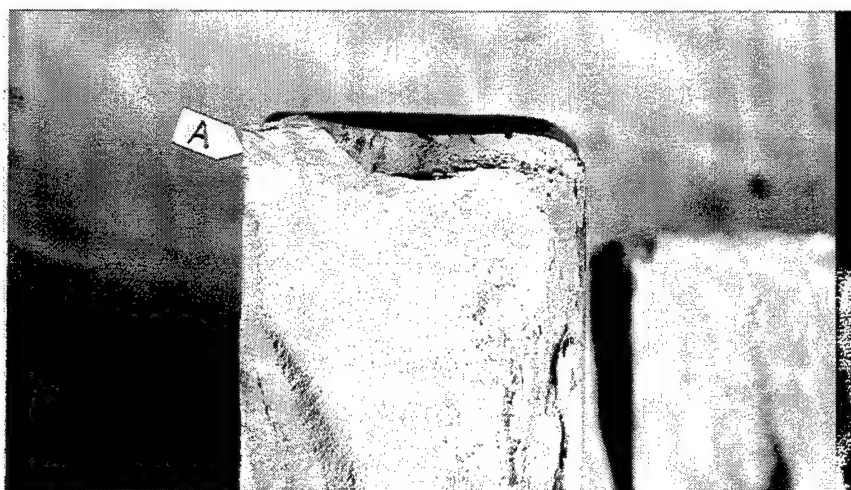
Figure 10. Close-up view of the same area in Figure 9, but under a different lighting condition to show the light-discolored area at the failure origin (A), indicating a fatigue crack. Magnification: Approx. 1.5 \times .

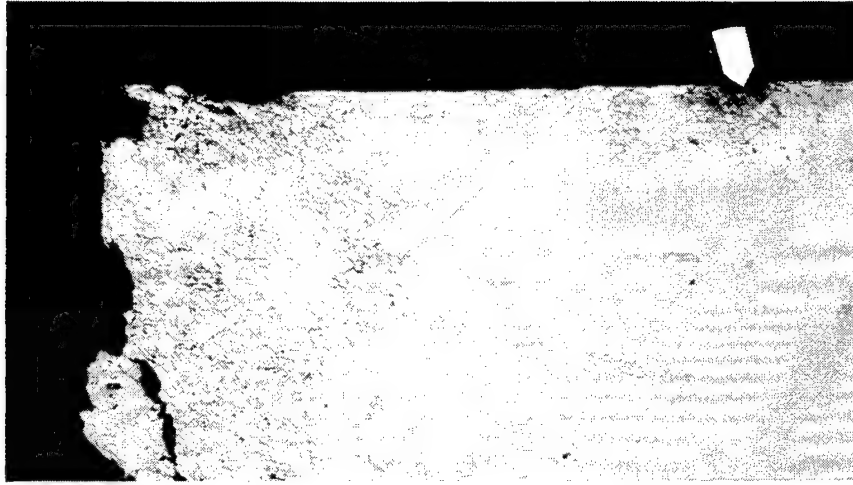
Figure 16. As-polished microstructure of the intergranular corrosion adjacent to the primary fracture (left side) and at a small surface corrosion pit (arrow) in the surface of the eyehole. The metallographic specimen was cut from the failure origin containing the fatigue crack. Magnification: 185x. Unetched.

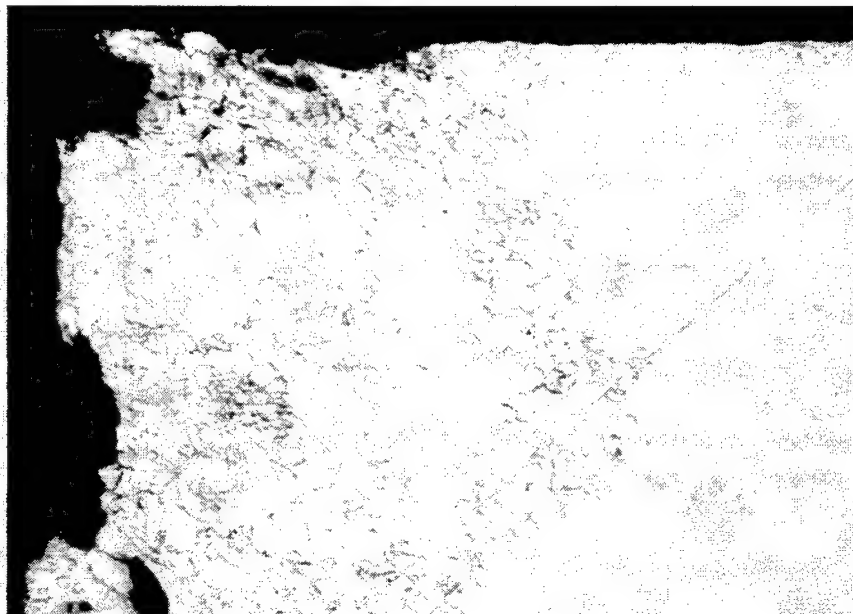
Figure 17. Same area in Figure 16, but at a higher magnification. Magnification: 365x. Unetched.

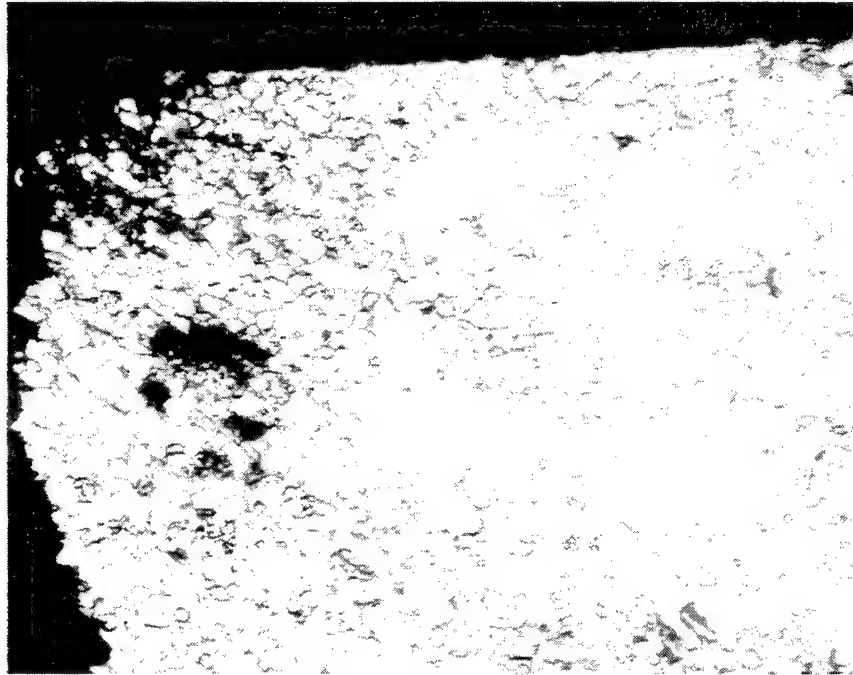
Figure 18. Same area in Figure 17, but etched to reveal the grain structure. Magnification: 365x. Keller etchant.

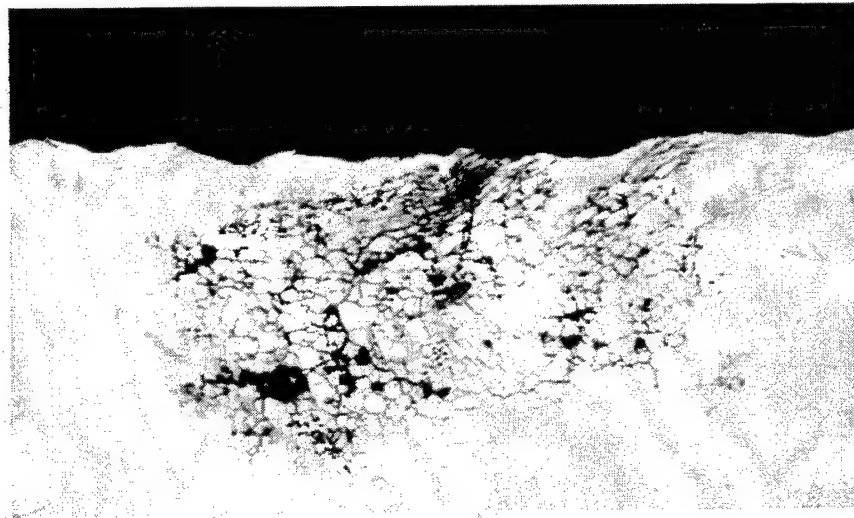
Figure 19. Enlarged view of the intergranular corrosion in a small corrosion pit in Figure 16. A small pit was started in the worn, bare surface of the eyehole, whereby intergranular corrosion spread out internally. Magnification: 365x. Unetched.

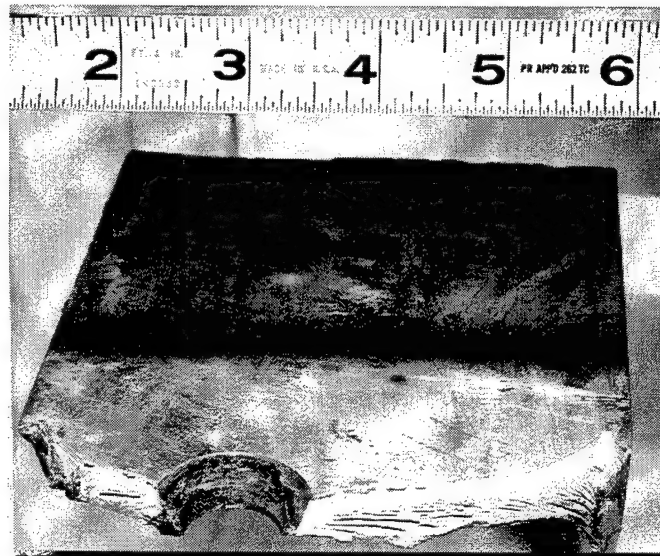
Figure 21. A view of the fractured surfaces of the right section of the broken angle in Figure 20.

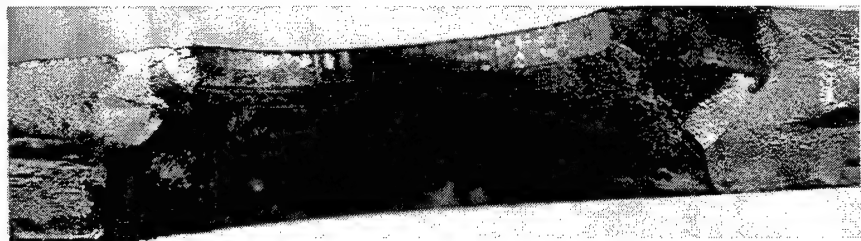
Figure 23. Same area of the fractured rivet hole in Figure 22 with a perpendicular view. Magnification: 2.9x.

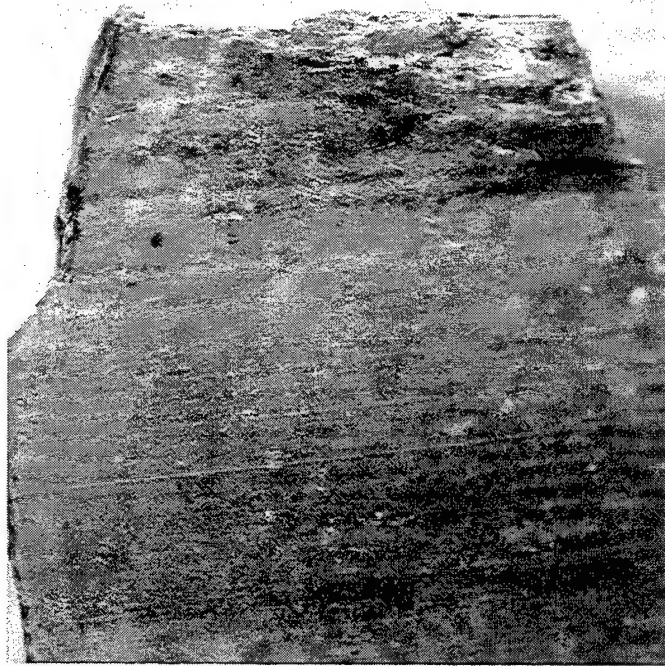
Figure 24. Enlarged view of the rivet hole edge with a crack (arrow) in the small angle piece (A) in Figure 20. Magnification: 15x.

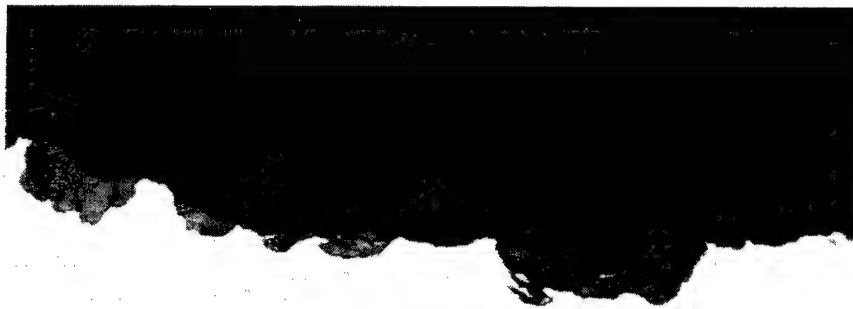
Figure 30. The bottom of the surface pit in Figure 29. The dark gray corrosion products embedded in the bottom, which account for the black color on the top surface of the angle. Magnification: 280x. Unetched.

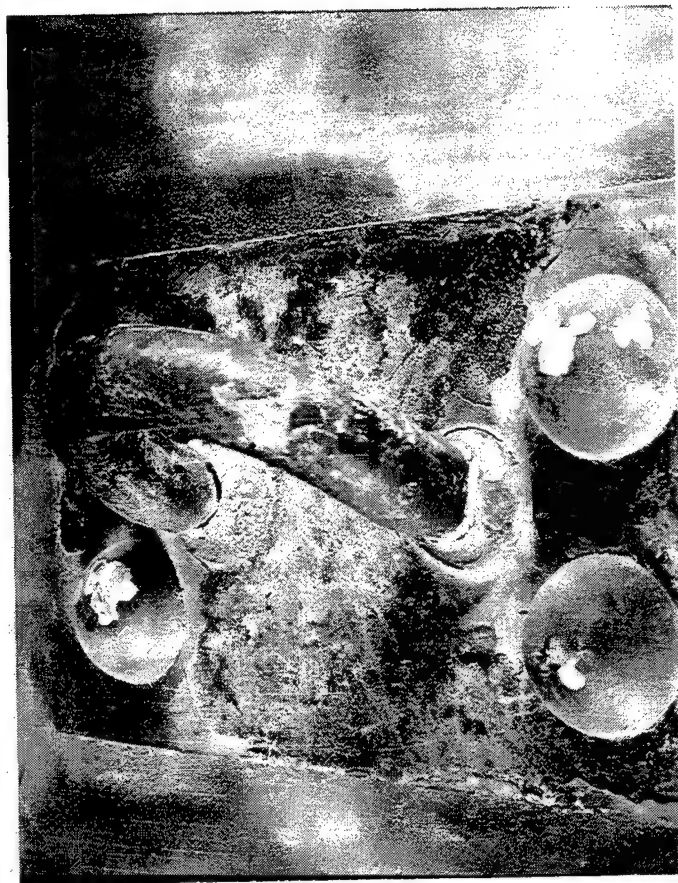
Figure 44. Close-up view of the failed tie-down device in Figure 43 after the removal of the wire rope for a clearer view.

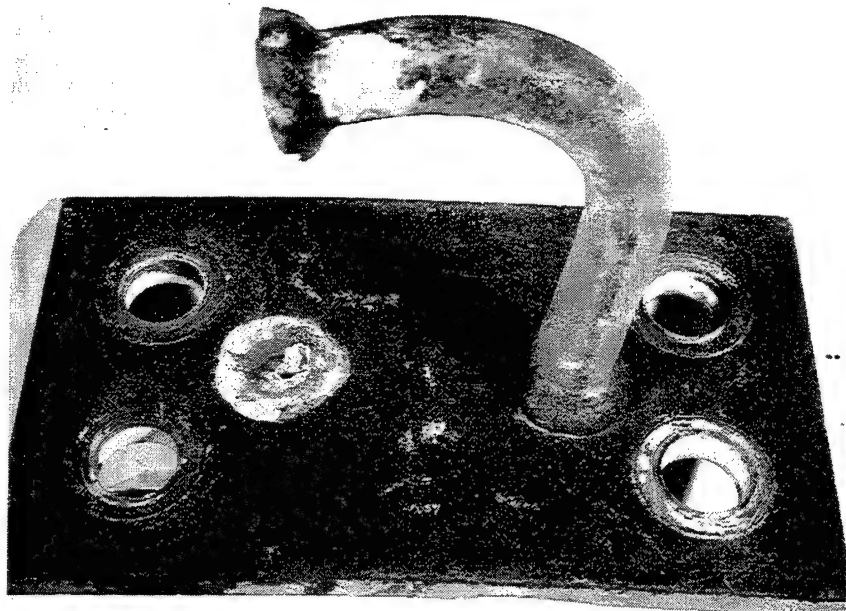
Figure 48. A view of the failed tie-down device after its removal from the test jig in Figure 47.

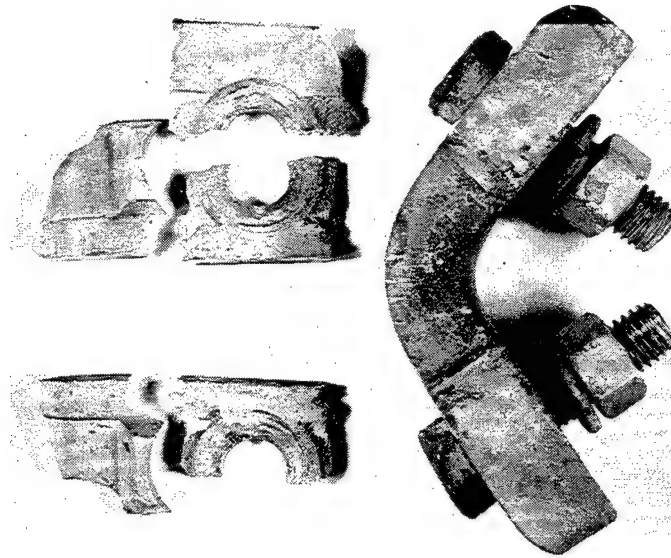
Figure 59. Broken pieces from the bolt holes at the oblong hole in the deck panel plus the bent lifting bar as the result of the pull test. Although not clearly seen in the photograph, discolored areas were observed in the fractured surfaces of the pieces.

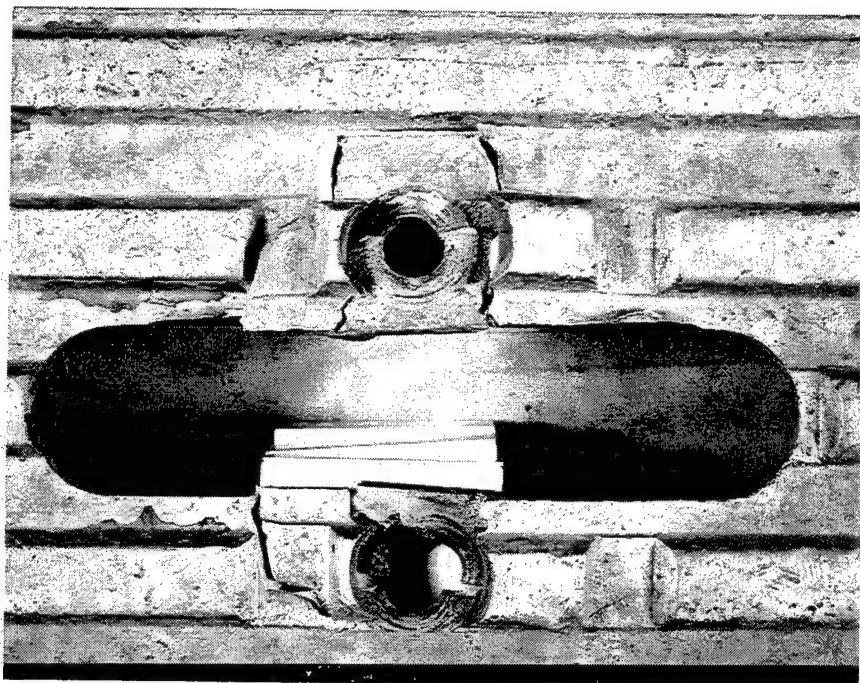
Figure 60. Broken deck panel pieces put back in place in the damaged oblong hole in Figure 58.

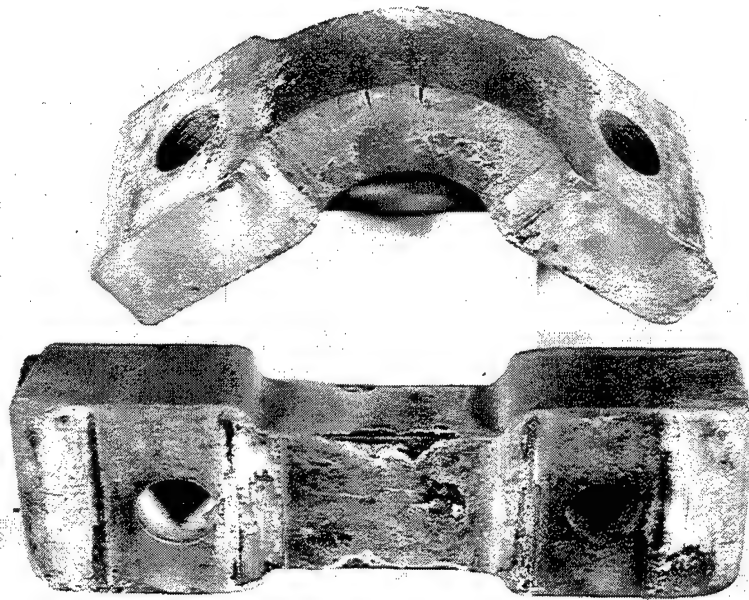
Figure 62. Comparison of the bent lifting bar (top) after the pull test to the straight bar. Note the "dogbone" shape of the lifting bar.

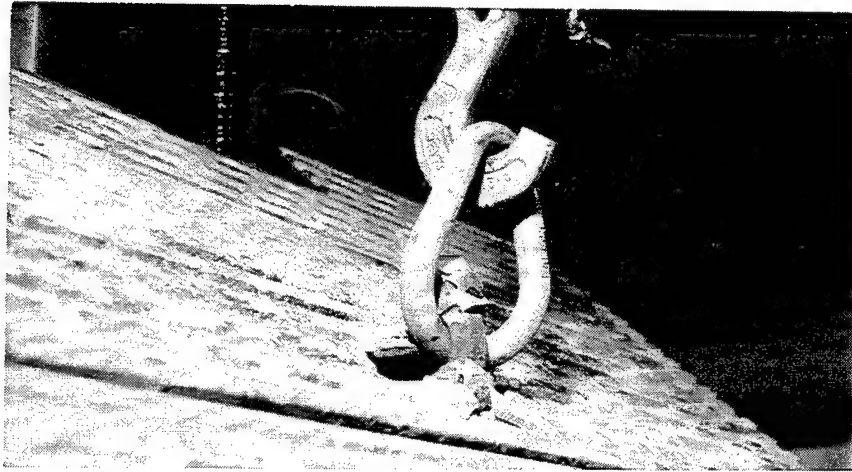
- Third pull test: This test was performed on the lifting device with the original mild steel lifting bar in another deck panel in order to determine the maximum load at the time of the device failure, provided that no pre-existent cracks were present in the bolt holes at the oblong hole in the panel as had happened to the panel in the first test. The test was performed in the same manner as the previous two tests, still using the same large AVLB section attached to the testing machine. The lifting device with the original lifting bar failed at 23,500 lb maximum in this test as compared to 20,250 and 28,500 lb in the first and second tests, respectively. The bar had bent at the steel ring (see Figure 66).

Figure 66. Damage to the original lifting device at the oblong hole in the AVLB deck panel after the third pull test. Note that the lifting steel bar was bent slightly around the egg-shaped steel ring.

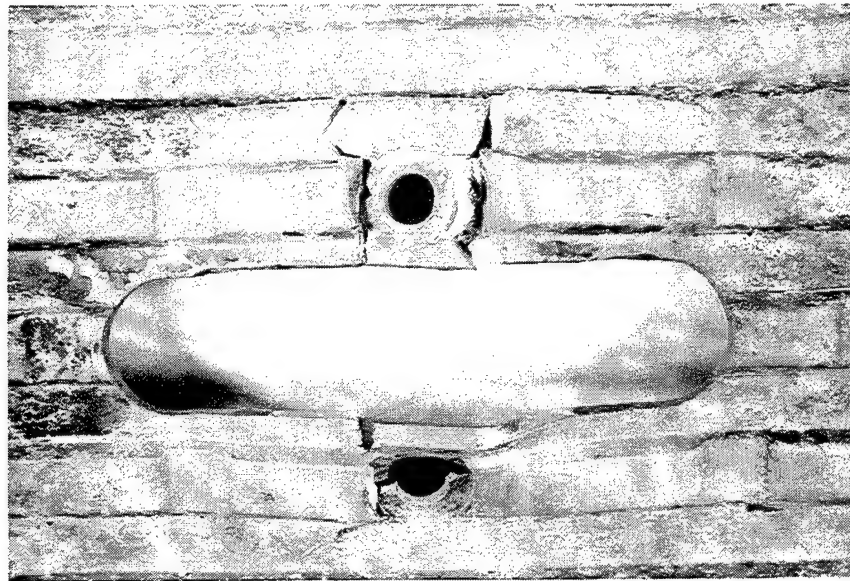
Figure 68. Same close-up view of the damaged oblong hole in Figure 67 after the removal of the lifting bar, bolts, and steel ring.

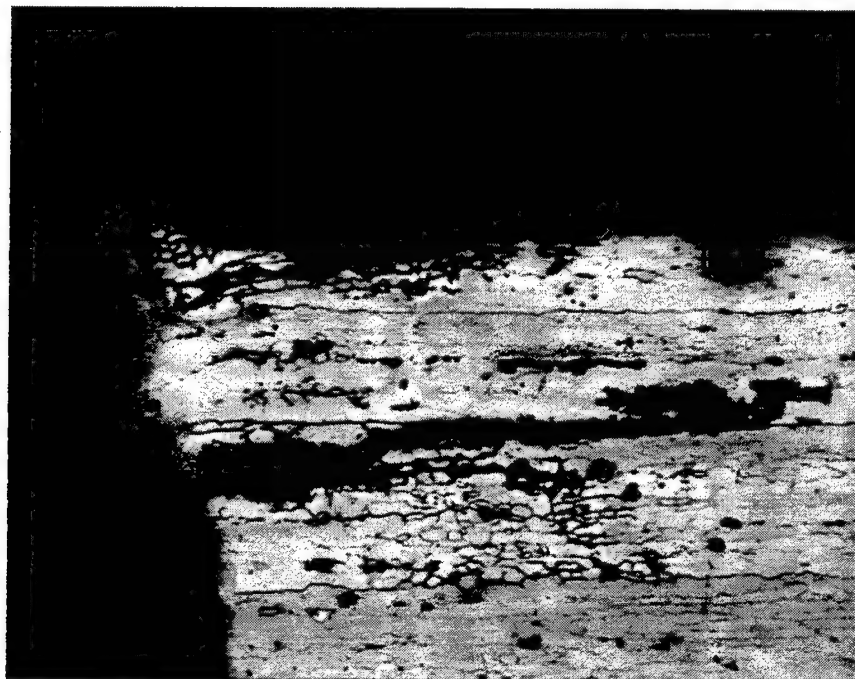
Figure 79. Etched microstructure of the same area in Figure 78. Magnification: 380x. Keller's etchant.

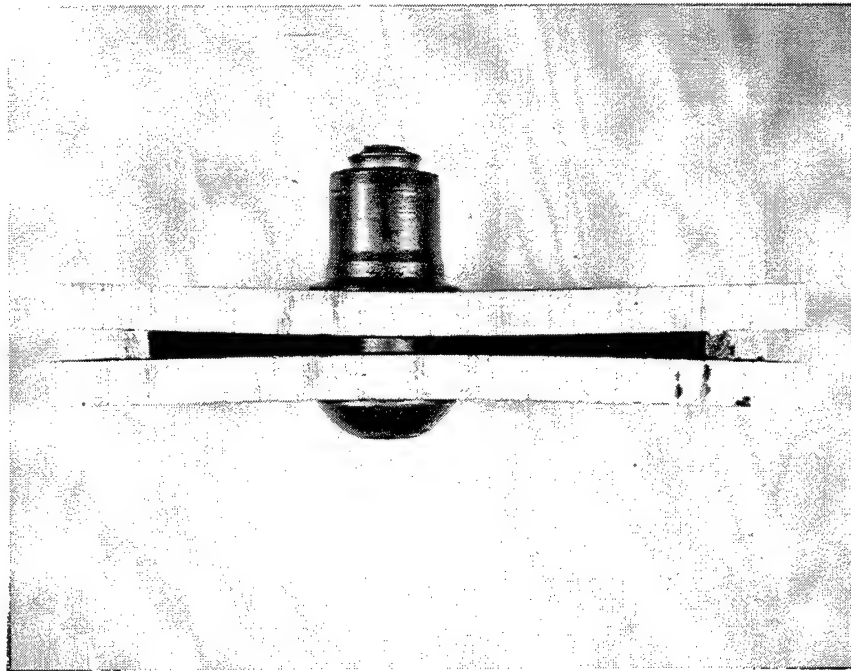
Figure 85. Edge view of the Huckbolt assembly test Specimen G. Two 1/4-in steel bars were used as spacers to form the 1/4-in gap between the angle legs. Note the amount of deflection in both legs when the fastener was installed to show the clamping action during the installation.

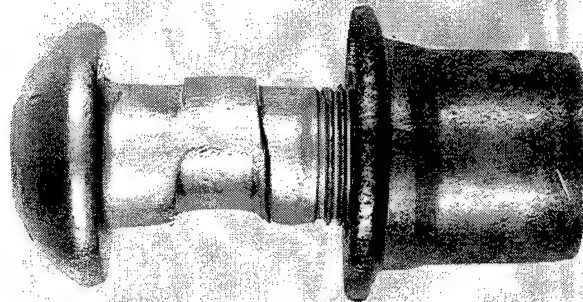
Figure 88. Double-sheared Huckbolt fastener from shear test Specimen A after the shear test. The collar was fully swaged. Actual size.

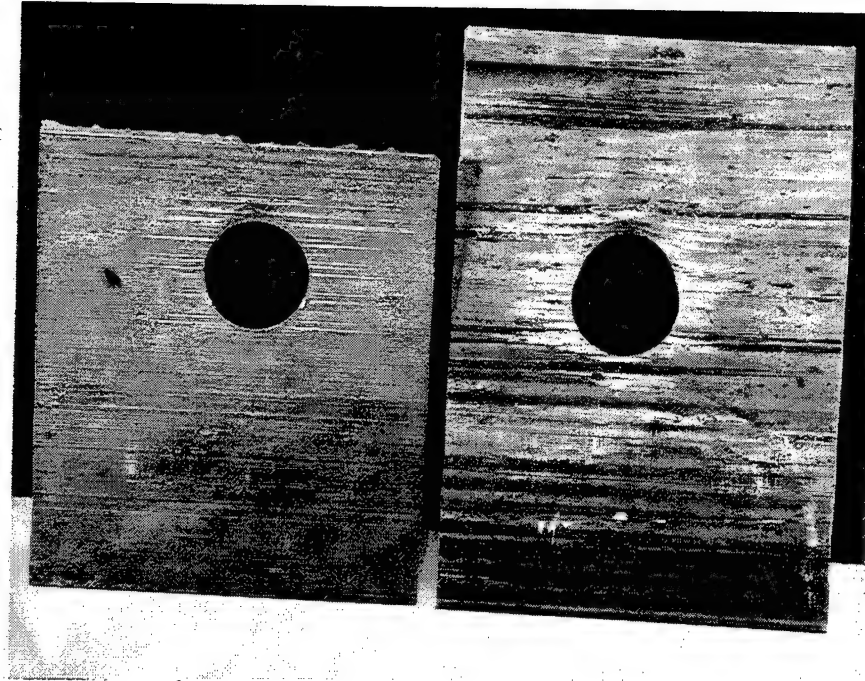
Figure 89. The effect of the shear test on the holes in shear test Specimen A. Note the elongated hole in the center piece (plunger) on right and very little elongation in the hole of the angle leg on left.

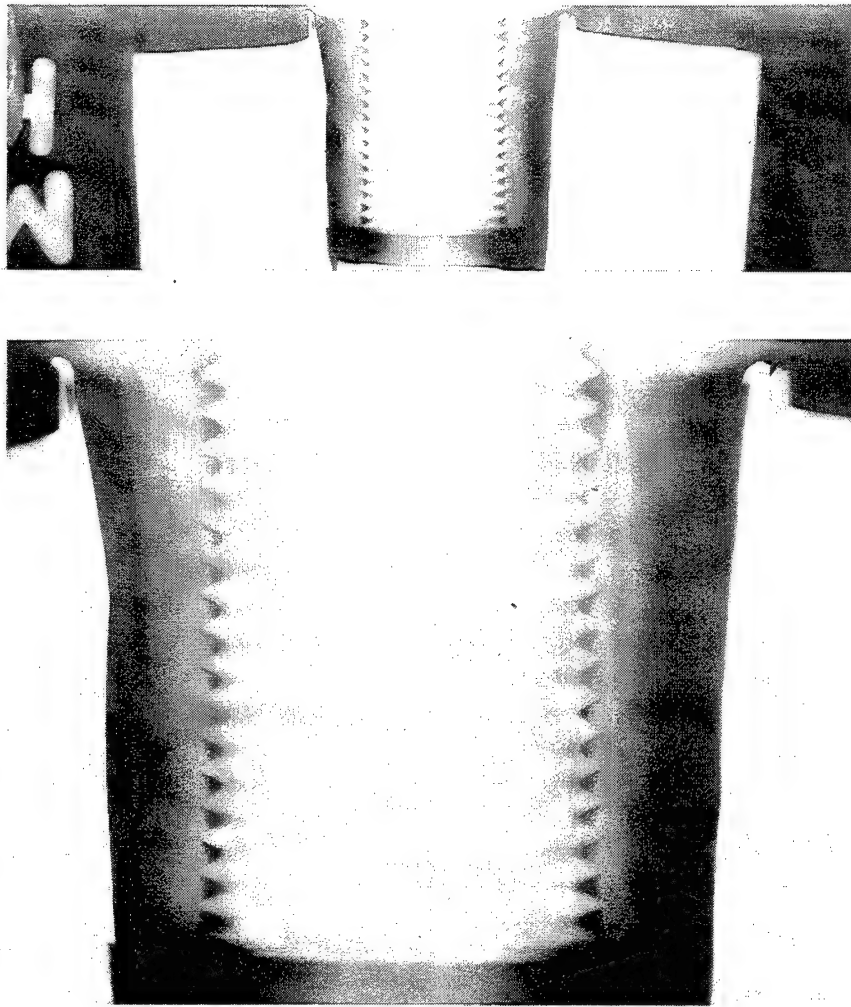
Figure 94. Photographs of a radiographic image of the collar fully swaged on the locking groove portion of the Huckbolt fastener pin. Shear test Specimen F. The push test was stopped at a 21,350-lb maximum load before the complete shearing of the collar interior wall. Note partial shearing of the wall in the image. Actual size (top). Magnification: $2\frac{2}{3}\times$.

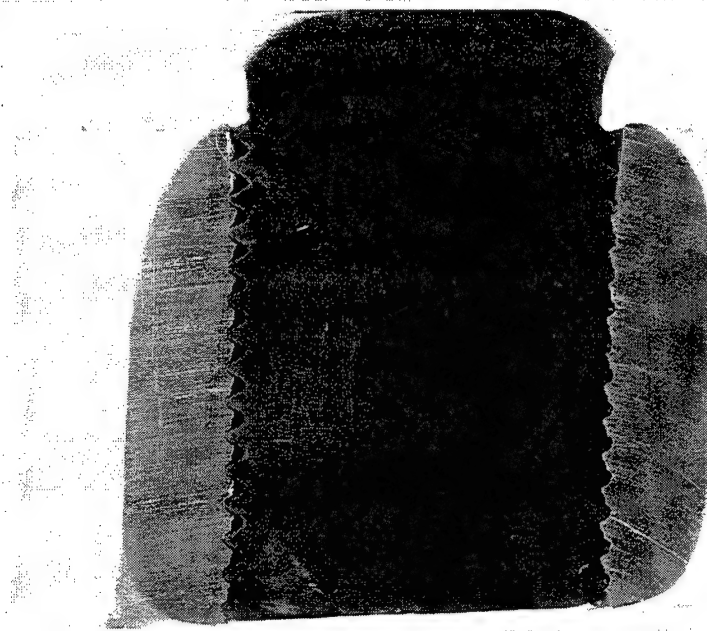
Figure 96. Cross sections of the Huckbolt pin with the locking grooves and the fully swaged collar showing the initial deformation in the collar interior wall penetrated by the tips of the locking grooves. The push test of Specimen F was stopped after the maximum load of 21,350 lb was reached and before the indented interior wall was to be stripped completely by the pin-locking grooves. See Figure 97 for the enlarged view. Magnification: 2.7x. 600-grit surface finish.

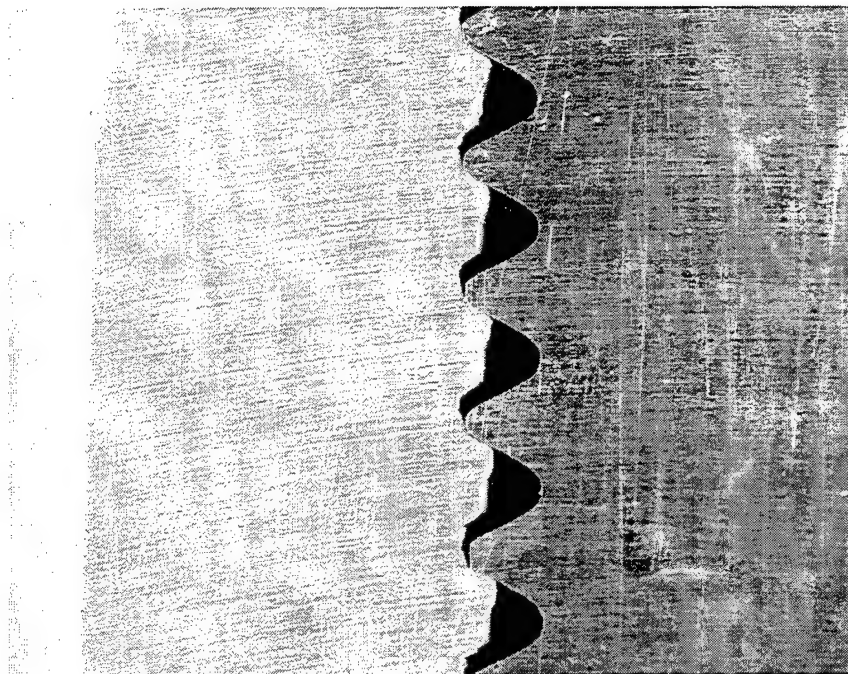
Figure 97. Enlarged view of the cross sections of the Huckbolt pin (right) and collar seen in Figure 96. Note the initial deformation of the indented interior wall of the collar. Magnification: 15×. 600-grit surface finish.

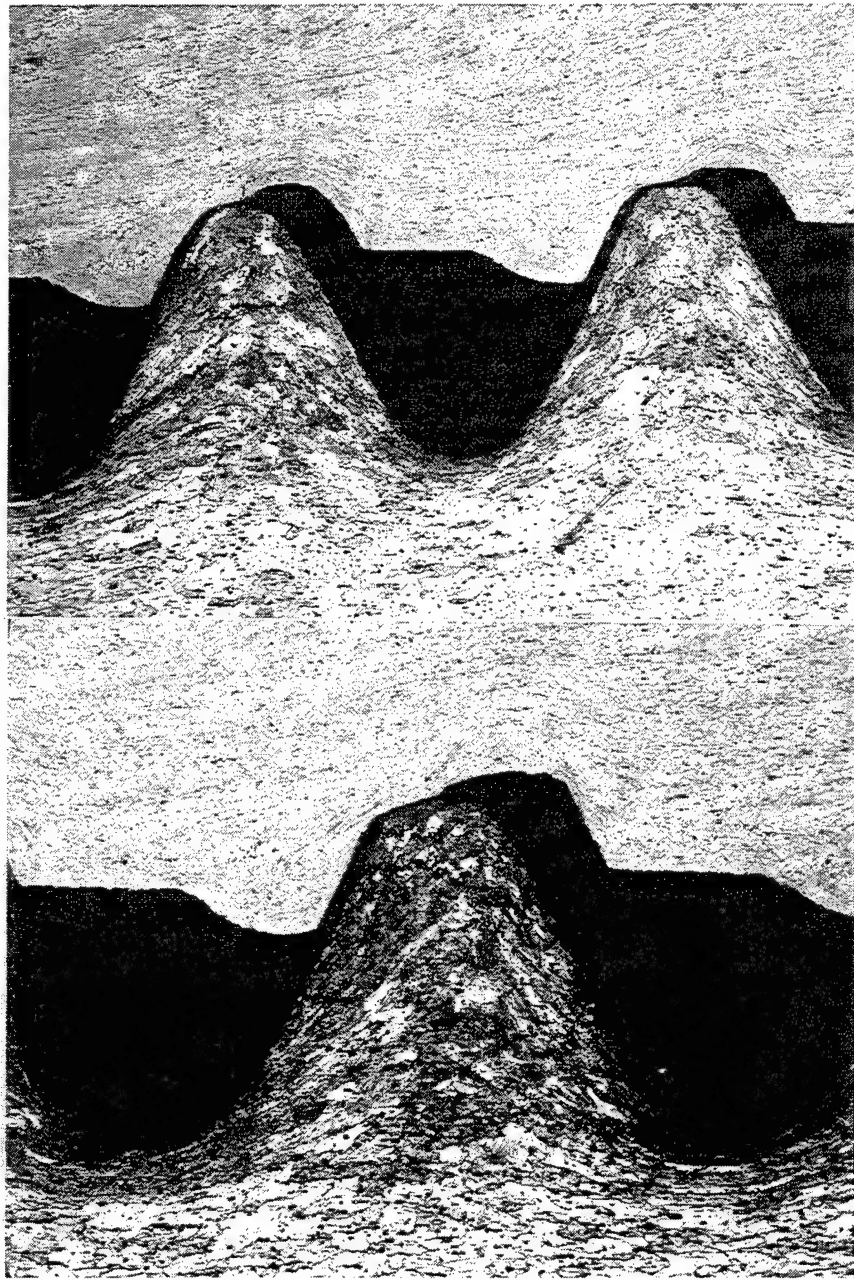
Figures 98 and 99 show the etched microstructures of the swaged collars and pins from Specimens F and D. Deformed grain structure can be seen in the pin-locking grooves, indicating that the grooves were cold-rolled on a portion of the pin shank by the manufacturer. Figure 100 is the sketch of the hardness survey made across the portions of the swaged collar and grooved pin of Specimen F. The hardness was higher in the cold-rolled groove tip, which explained why the locking grooves were not damaged when they penetrated and sheared the interior wall of the swaged collar during the push test. The collar was softer than the pin to permit ease of swaging during the installation of the Huckbolt fastener. Partial penetration of the pin-locking grooves into the interior wall of the swaged collar instead of full penetration was sufficient for the clamping or holding purposes for the intended application.

Figure 98. Two magnifications of the etched microstructure of the Huckbolt-pin-locking grooves (bottom of both photographs) and the indented interior wall of the swaged collar of Specimen F in Figures 96 and 97. Note the deformed grain structure in the locking grooves because of the cold rolling of the grooves on the pin. Also note the buildup of the metal in the interior wall of the collar by the penetrated grooves just after the maximum load was reached and before complete stripping of the indented wall had occurred. Magnification: 40× (top) and 50× (bottom). Keller's etchant.

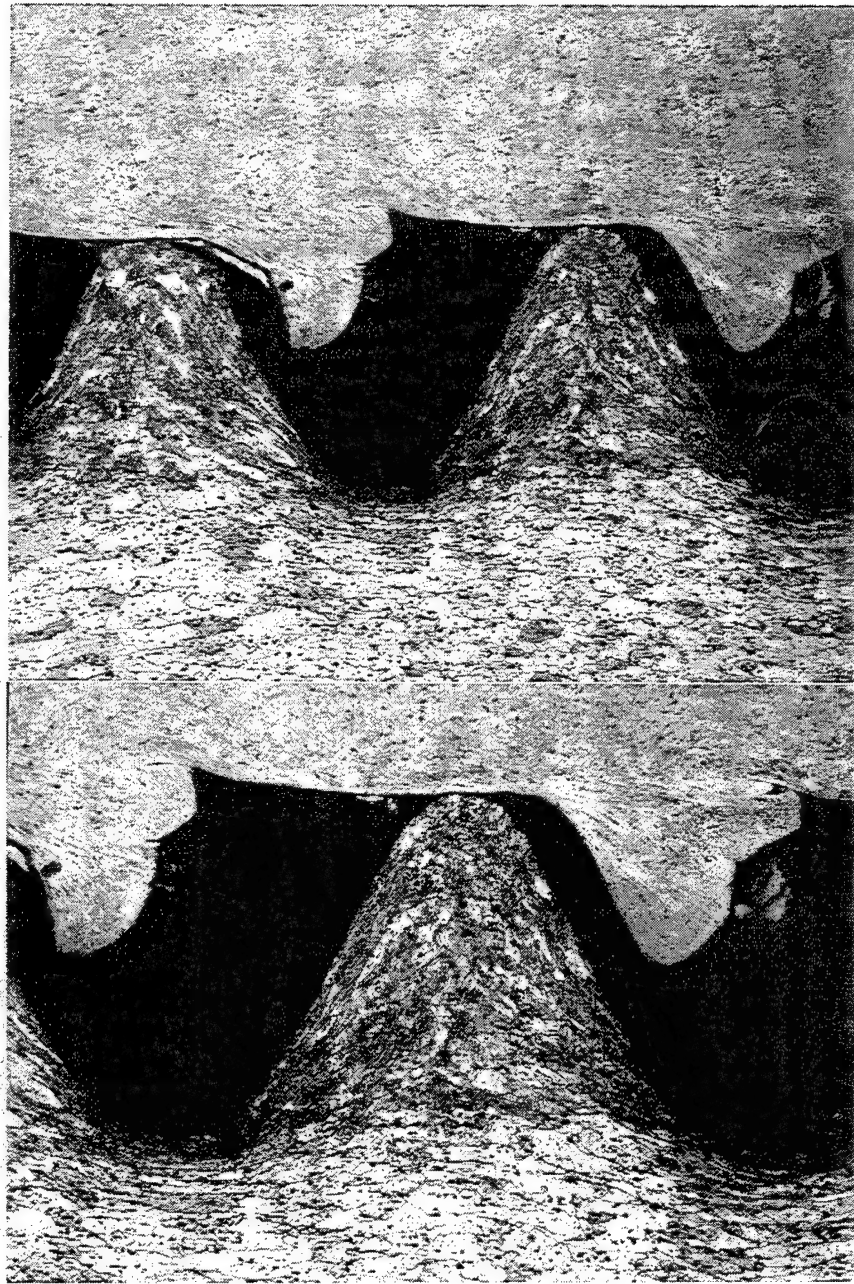
Figure 99. Two magnifications of the etched microstructure of the Huckbolt-pin-locking grooves (bottom of both photographs) and indented interior wall of the 1/4 swaged collar of shear test Specimen D. Note the buildup of the metal in the wall by the penetrated grooves after going beyond the maximum load just before complete shearing of the indented wall took place. The locking grooves of the pin were cold rolled as indicated by the deformed grain structure. Magnification: 40× (top) and 50× (bottom). Keller's etchant.

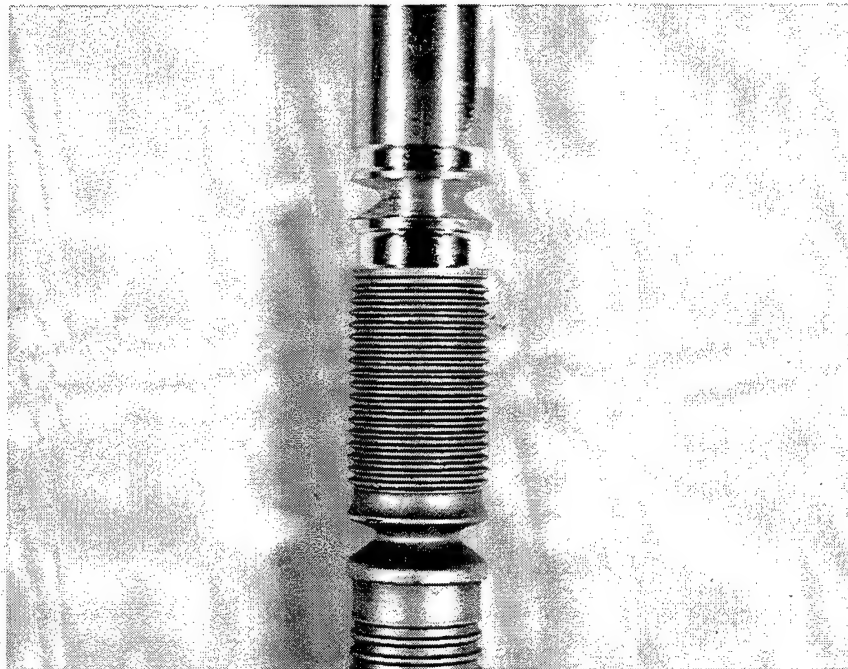
- A third pin sample that has a similar breakaway notch machined on the smooth pin shank (see Figure 102) in order to determine the effect of the notch in the base metal in the area that was not affected by cold rolling as had occurred in the original cold-rolled breakaway notch. The pin sample broke in the machined notch rather than in the cold-rolled notch.

Figure 102. A view of two large breakaway notches on the same Huckbolt pin sample. The upper notch was machined to the same shape and size as the original cold-rolled notch below. The machined notch was located in the smooth shank section of the pin that was not cold rolled.

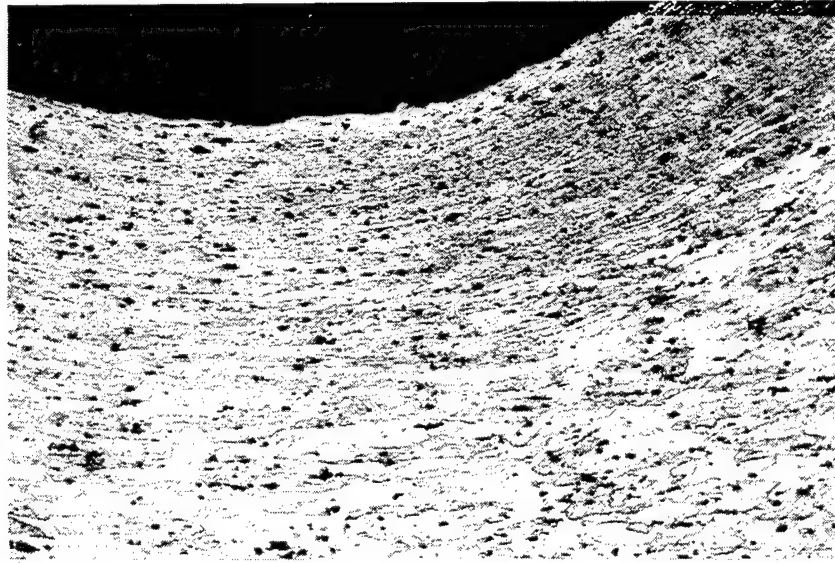
The results of the tensile tests on the 3/4-in-diameter Huckbolt fastener aluminum pin samples are given in Table 8. The average load required to break off the installation stem at the large cold-rolled breakaway notch of two pin samples was 15,840 lb, which translated to 113,790-psi notch tensile strength. Meanwhile, the breaking load and notch tensile strength were 13,340 lb and 90,180 psi, respectively, for the machined notch in the smooth, not cold-rolled shank area of the third pin sample, confirming that the effect of cold rolling the large breakaway notch in the pin had resulted in higher tensile properties. The microstructural examination of the metallographic specimen containing the cross section of the large breakaway notch revealed the elongated grain structure in the notch area as the result of cold rolling as was normally done during the manufacture of the Huckbolt aluminum pins (see Figure 103).

Figure 103. Etched microstructure at the root of the cold-rolled breakaway notch of a Huckbolt aluminum pin sample. Elongated grain structure is seen at the surface edge of the notch, indicative of surface cold rolling. Magnification: 100 \times . Keller's etchant.

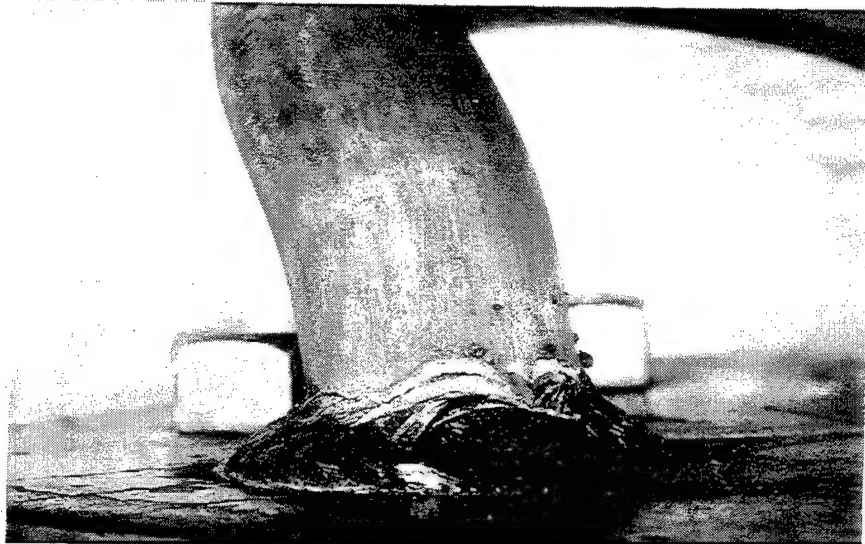
Figure 112. Closer view of the crack in the upper toe of the fillet weld in the damaged lifting device in Figure 111. Larger than actual size.

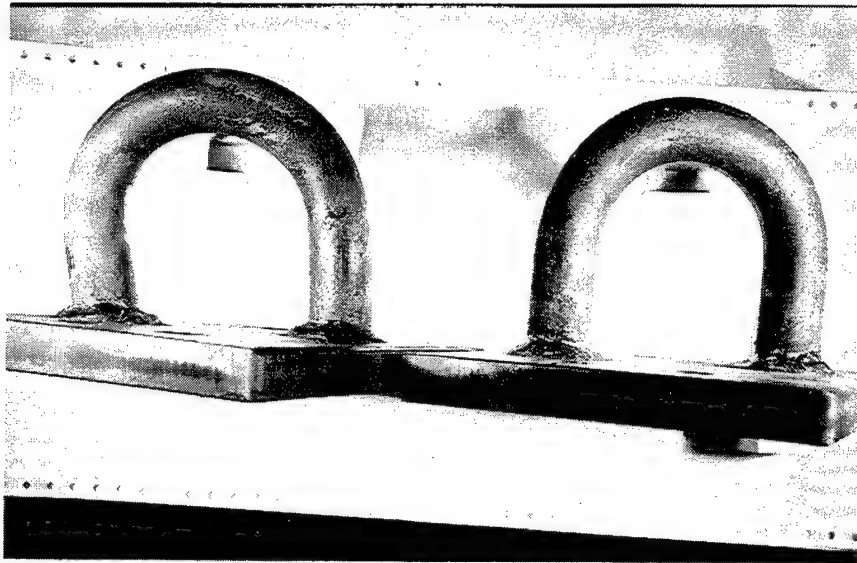
(3) Parallel pull tests (Nos. 5 and 6) whereby the load was applied to the U-shaped bar which was in the vertical position in the testing machine (see Figures 113 and 114 for the test setup). This will cause the upper leg of the bar with the hook under it to be under load up to 40,000 lb maximum. Figure 115 shows the extent of permanent damage to the leg under the hook after the pull tests. According to the load-deflection curves obtained, the upper leg of two devices tested started to bend permanently at about 22,000–23,000 lb.

Figure 115. A view of the tested new lifting device (left) compared to the untested device after the parallel pull test. Note the extent of permanent damage to the left leg of the tested device as the result of the pull test.

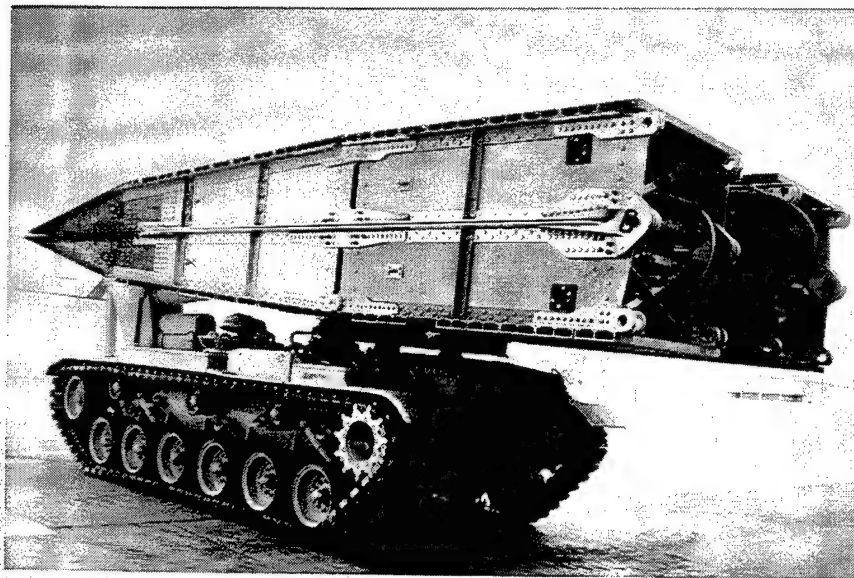
Figure 116. A Class 70 Modified AVL in the folded position on top of the armored vehicle bridge launcher. The bridge is composed of four bridge sections (two females and two males) to form two treadways.

2.16 Inspection and Testing of Two Class 70 Modified AVLBS. Again, based on the findings of the various tests performed at Belvoir by this laboratory during the Class 70 AVLB modification program, ANAD had modified two current Class 60 AVLBS to Class 70 for tests and performance evaluation (see Figure 116). The following modifications were made on both AVLBS at the depot:

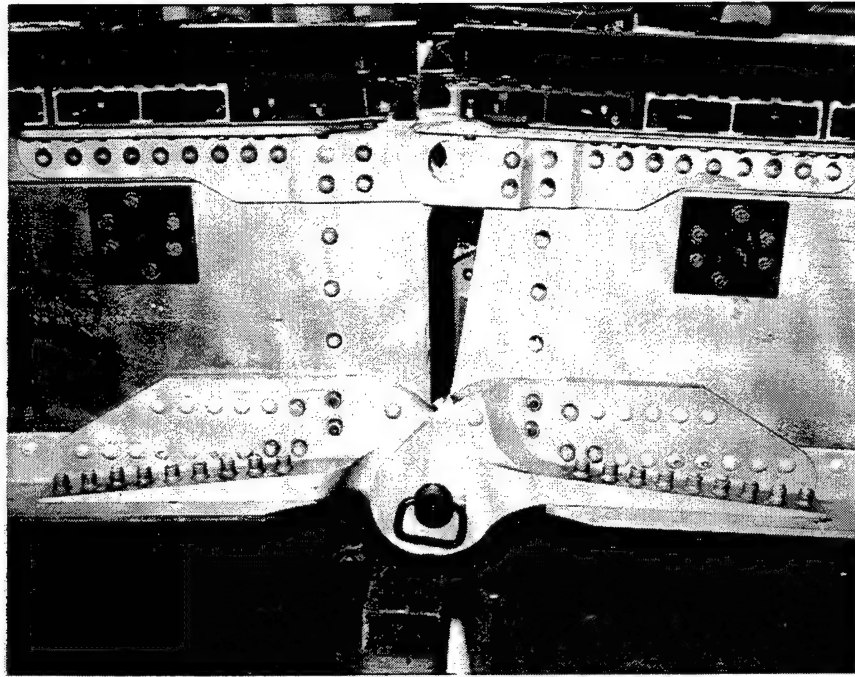
Figure 117. Close-up view of the new larger machined aluminum center hinges on the ends of the bottom chords. The hinges were made of stronger aluminum alloy 7050 and were fastened to the aluminum girder plates and larger alloy 7050 bottom chord angles with the Huckbolt fasteners. The flanged aluminum collars are seen on top of the hinge bottom flanges. Note the new steel lifting devices bolted to the girder plate of both bridge sections (the female section is on the right) after the original steel tie-down devices (see Figure 118) were removed. Also note the steel curbs bolted on top of the extruded aluminum deck panels.

- Larger center hinges to be made of stronger forged aluminum alloy 7050-T7452 to replace alloy 2014-T6 (see Figure 117). Because the hinge forgings would not be available during the modification of two bridges, the hinges at that time were machined from large alloy 7050 plates or forged billets.

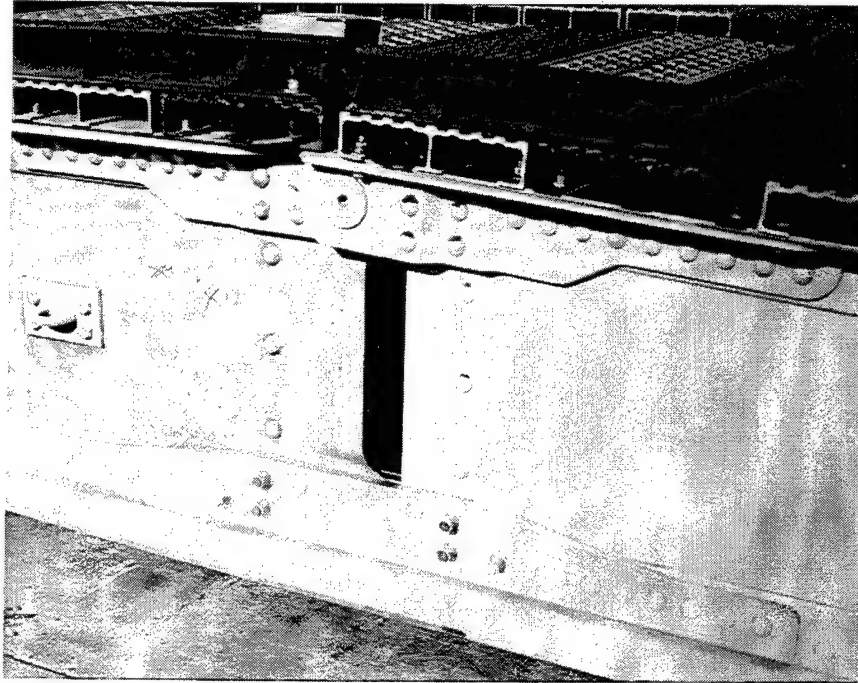
Figure 118. Close-up view of the aluminum alloy 7050 reinforcement bar fastened to the bottom chord angles and girder plates. It joined the center (left) and the end panel assemblies together permanently after the forged aluminum bottom connectors, similar to the top connectors, were eliminated as part of the Class 70 modification. The bottom chord angles were continuous across the joint. The Huckbolt fasteners were used to fasten the flat bar at the joint. The original steel tie-down device was now bolted to the girder plate of the center panel assembly.

- Larger and stronger bottom chord aluminum alloy 7050-T76511 angles in place of original alloy 2014-T6 angles. The angles were long enough to join the center and end panel assemblies permanently to form one bridge section after the forged bottom aluminum connectors were removed entirely. Alloy 7050 flat bars were used as reinforcements at the joints (see Figure 118).

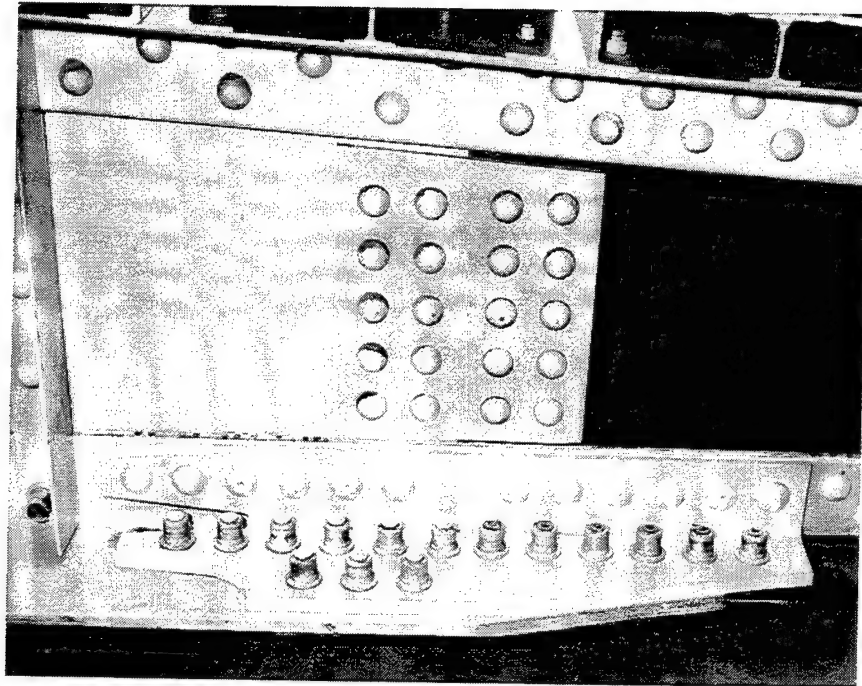
Figure 119. Close-up view of the modified larger angle splice fastened to the bottom chord angles and girder plates at the spliced joint. This is where the steel ramp end section (dark area at right) was spliced to aluminum section on left. It was made of stronger alloy 7050, and the Huckbolt fasteners were used as seen with the flanged collars. There is no sharp notch in the new angle splice as was seen in the original splices that sometimes were cracked (see Figures 2 and 120).

- Larger and stronger aluminum alloy 7050-T76511 angle splices at the joint where the steel ramp end section was spliced to the aluminum section of the end panel assembly (see Figures 119 and 120). Also, a 1/4-in-thick T-1 steel bottom plate was used in place of alloy 2014-T6 at the splice joints.

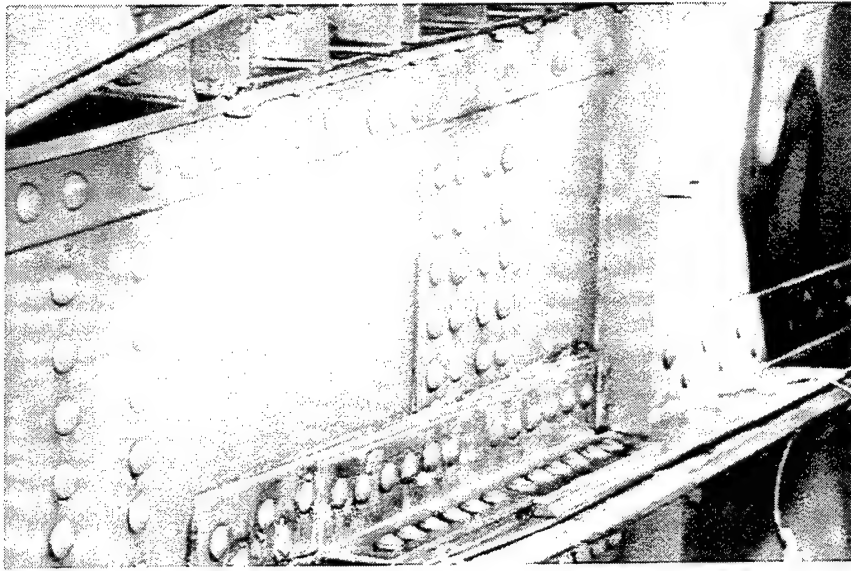
Figure 120. A view of the original angle splice on the current Class 60 AVLB for comparison to the larger modified splice in Figure 119. It contains the sharp angular notch in the cutout on the bottom angle leg. Note the use of the hot-driven aluminum rivets in the splice.
